**OPERATION SAN FRANCISCO**

**The International Association of Fire Chiefs**  
**San Francisco Fire Department • Marriott Corp.**

# OPERATION SAN FRANCISCO

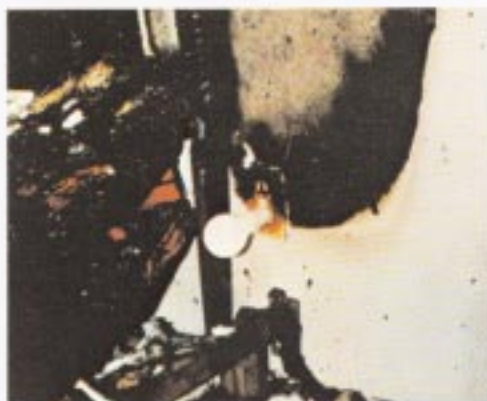
① This wall receptacle in the apartment master bedroom shows the extent of fire damage to bed frame, wall and outlet plate, while circuit operation is demonstrated by light. Recorded room temperatures are shown in Graph A. See Diagram II.

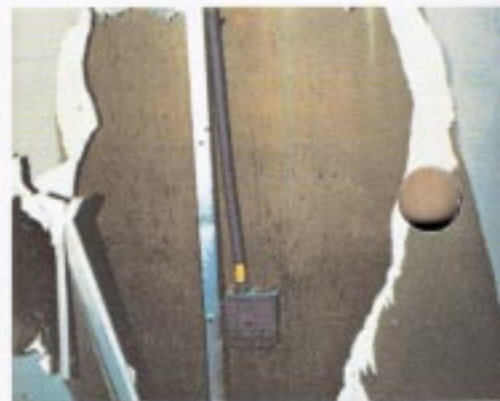
② This is the reverse side of photo #1 showing the reverse side of the wall receptacle and tubing, which are intact and undamaged. See Diagram II.

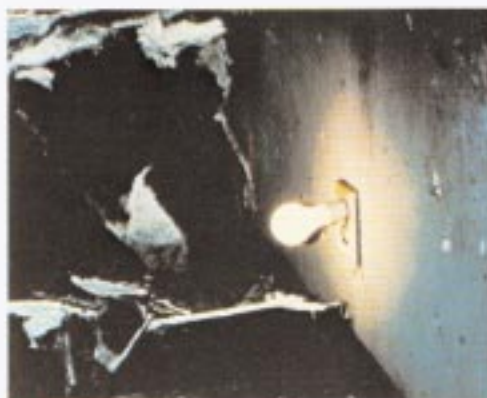
⑥ This receptacle is located in room 206 and is operative after flashover. Room temperatures during flashover shown in Graph B. See Diagram II.

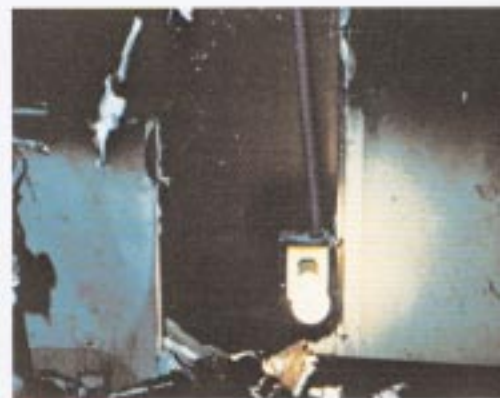
⑦ This photo shows same receptacle as photo 6, but the wall board was removed to show wiring and box intact. See Diagram II.

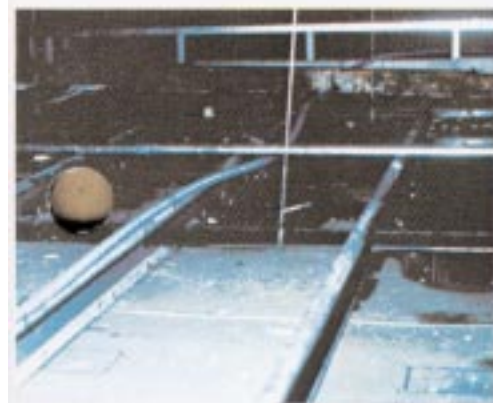
**3** Electrical nonmetallic tubing running across ceiling of apartment master bedroom showing effects of fire but tubing intact. See Diagram II.

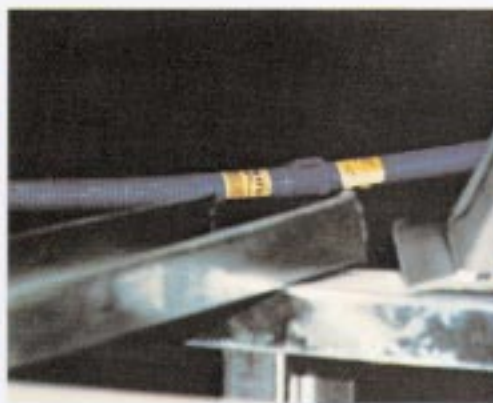
**4** ENT™ running above apartment bedroom showing coupling for tubing. See Diagram II.

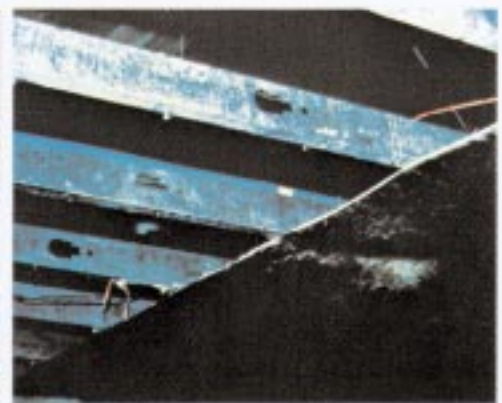
**5** The raceway in this photo is mounted above room 206. This room was one picked for a flashover fire on final day. See Diagram II and Graph B.

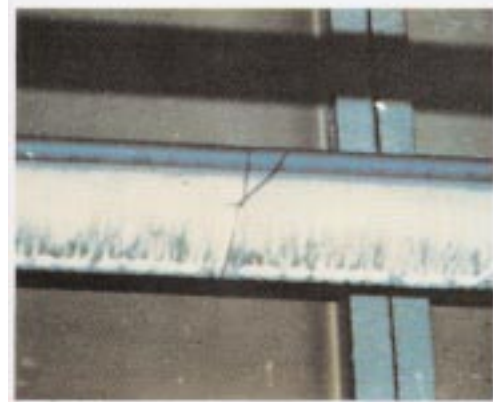
**6** Raceway secured to pipe above Blue Ballroom feeding four outlet and switch boxes in room. See Diagram I and Graph C.

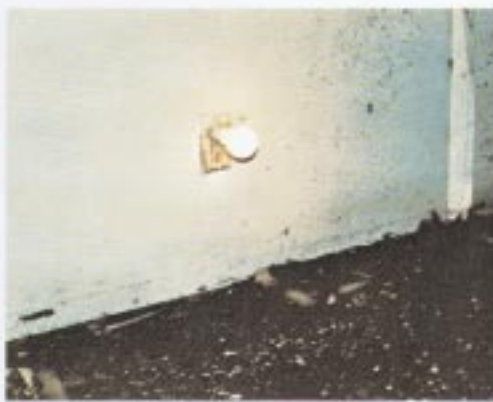
**9** Outlet box in Blue Ballroom still functioning after final room burn (flashover). Temperatures are recorded in Graph C. See Diagram I.

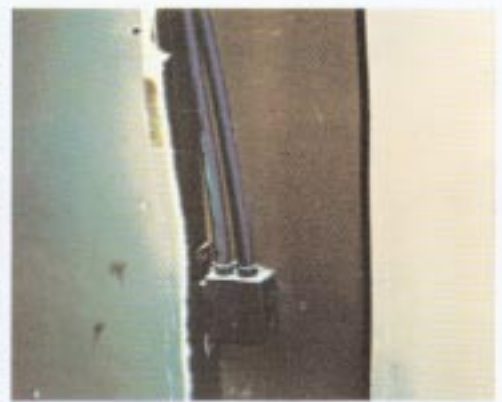
**10** Outlet box shown in photo 9 from exterior of room with wall board cut away to show box and tubing still undamaged. See Diagram I.
