**OPERATION SAN FRANCISCO**

**The International Association of Fire Chiefs**  
**San Francisco Fire Department • Marriott Corp.**

# OPERATION SAN FRANCISCO

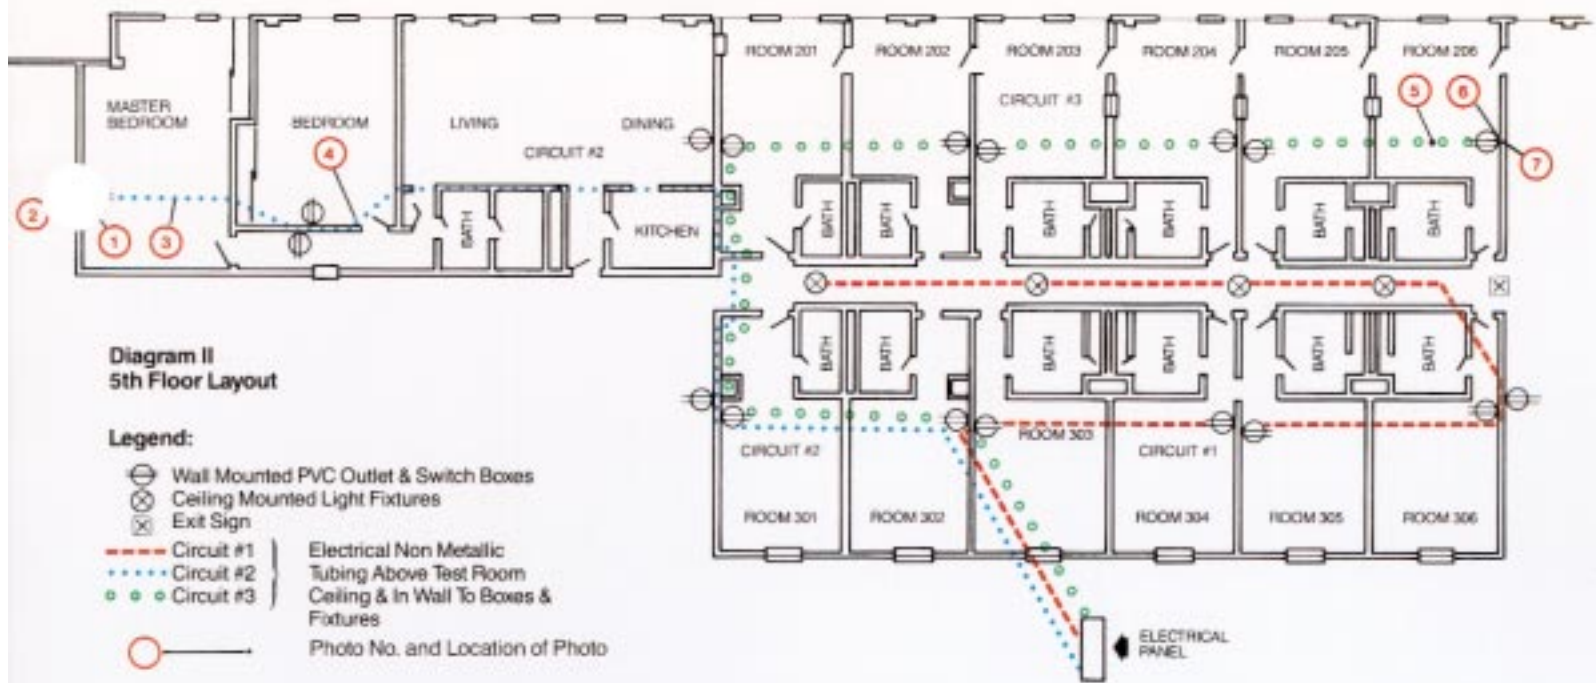
**3** Electrical nonmetallic tubing running across ceiling of apartment master bedroom showing effects of fire but tubing intact. See Diagram II.
